Manhole Inspection Summary

Manhole # S07MM1019MH

Insp Date: **5/31/07 11:18 AM**

Location Address: **3518 OAKMONT AVE**

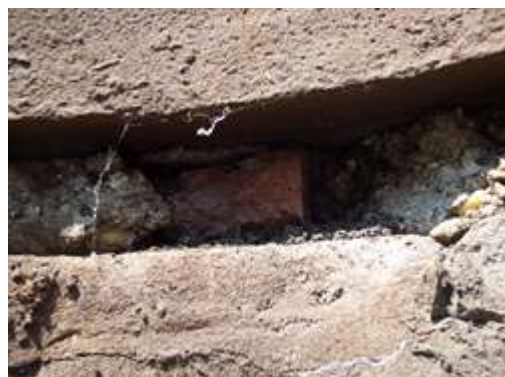
Defect 4

Condition: ☐ Sound ☐ Cracked ☐ Root Intrusion ☐ Loose Brick ☒ **Deteriorated**

GRADE ADJUSTMENT
DETERIORATION

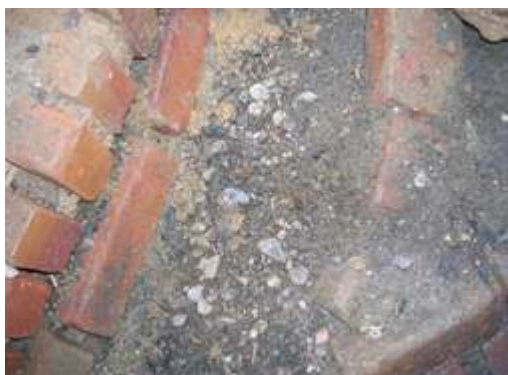
Defect 3

LINE TWO (DEBRIS)

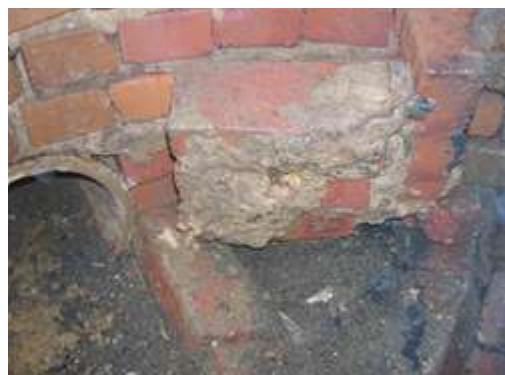
Defect 2

INTRUSION/CLUMP OF BRICK ON
BENCH

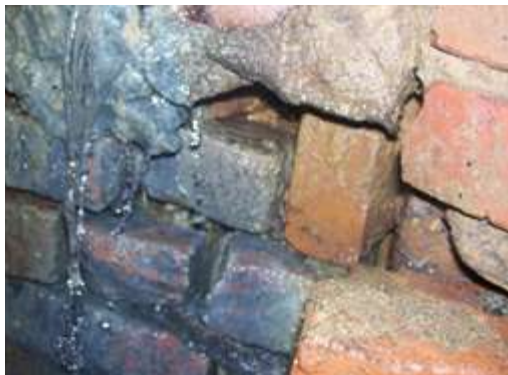
Defect 1

Condition: ☐ Sound ☐ Cracked ☐ Root Intrusion ☒ **Loose Brick** ☐ Deteriorated

LOOSE BRICKS/ MORTAR MISSING/
WALL WET FROM THE PIPE ABOVE IT
(INCOMING)

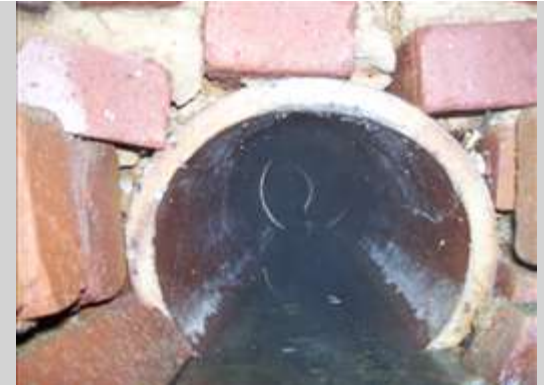
12 O'Clock Outflow

8 in. Circular Gravity Sewer
Pipe Out @ 12 O'Clock

Pipe Height: (in.) Direct
Pipe Material: **Clay** ☐ Pipe Lined
Invert Depth: **7.33** (ft.) Flow Characteristics: **Slow**
Deposits: ☐ None ☐ Mud ☐ Sludge ☒ **Debris** ☐ Grease
Silt Depth: **1** (in.) Deposits Extent: **Light**
Infiltration: **None** Pipe Seal Cond: **Broken**

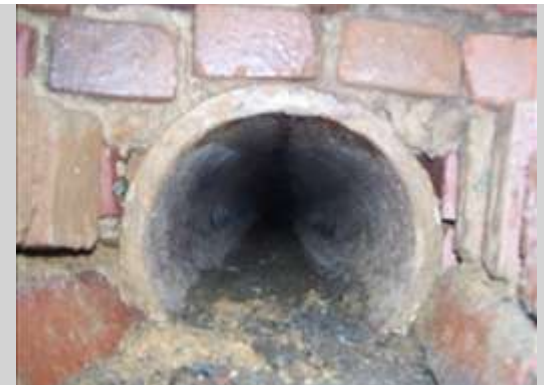
3 O'Clock Inflow

8 in. Circular Gravity Sewer
Pipe In @ 3 O'Clock

Pipe Height: (in.) Direct
Pipe Material: **Clay** ☐ Pipe Lined
Invert Depth: **7.23** (ft.) Flow Characteristics: **None**
Deposits: ☐ None ☐ Mud ☐ Sludge ☒ **Debris** ☐ Grease
Silt Depth: **1** (in.) Deposits Extent: **Light**
Infiltration: **None** Pipe Seal Cond: **Broken**

Connects To: **Stub connection / abandoned**

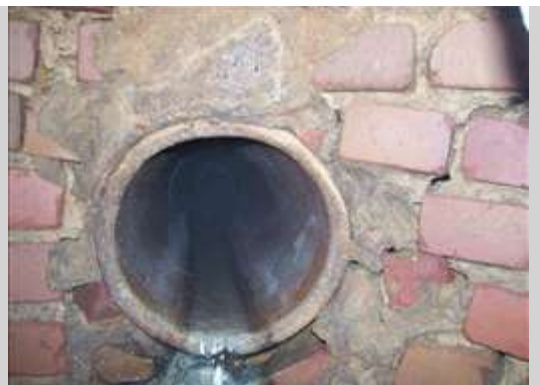
6 O'Clock Inflow

8 in. Circular Gravity Sewer
Pipe In @ 6 O'Clock

Deposits: ☐ None ☐ Mud ☐ Sludge ☒ **Debris** ☐ Grease

Silt Depth: **1** (in.) Deposits Extent: **Light**
